RP 21

# GUIDE TO COMMON SHIPBOARD EXPENDABLE BATHYTHERMOGRAPH (SXBT) RECORDING MALFUNCTIONS

BARRY P. BLUMENTHAL  
STEPHEN M. KRONER

AUGUST 1978  
REVISED FEBRUARY 1981

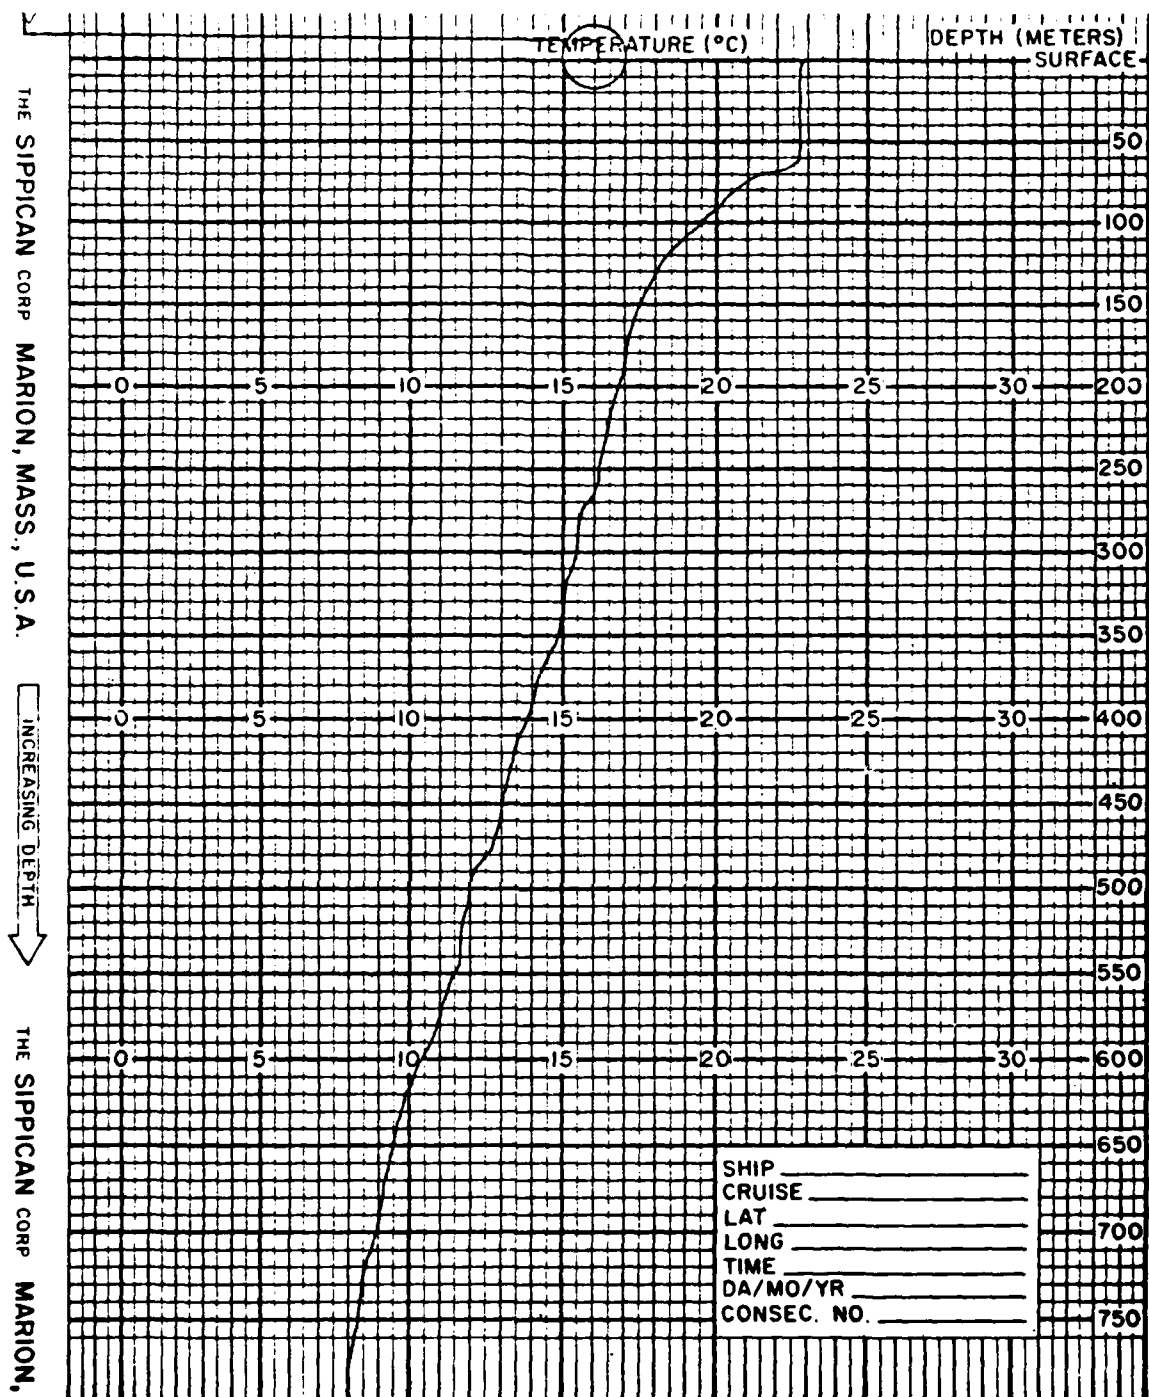
Category 1 - Check mode calibration mark other than 16.7°C (62°F): The calibration marks on figures 3 and 4 are not within specifications. These probes should not have been launched. The system is out of calibration and should be adjusted according to procedures described in appendix A. When the recorder is calibrated to within  $\pm 0.1^{\circ}\text{C}$  at  $-1.1^{\circ}\text{C}$  and  $34.4^{\circ}\text{C}$  ( $\pm 0.2^{\circ}\text{F}$  at  $30^{\circ}\text{F}$  and  $94^{\circ}\text{F}$ ), a temperature mark other than  $16.7^{\circ}\text{C}$  ( $62^{\circ}\text{F}$ ) during the Check/Run Mode indicates a defective servo potentiometer or printed circuit board.

Figures 3 and 4 show a temperature other than the  $16.7^{\circ}\text{C}$  calibration mark; therefore, they cannot be used for accurate thermal analyses nor used as input to historical data files. However, significant acoustical parameters such as general temperature structure, layer depth, and in-layer and below-layer gradients can be determined from such traces.

Figure 3 - Check mode calibration mark other than 16.7°C (appears at 16.1°C)

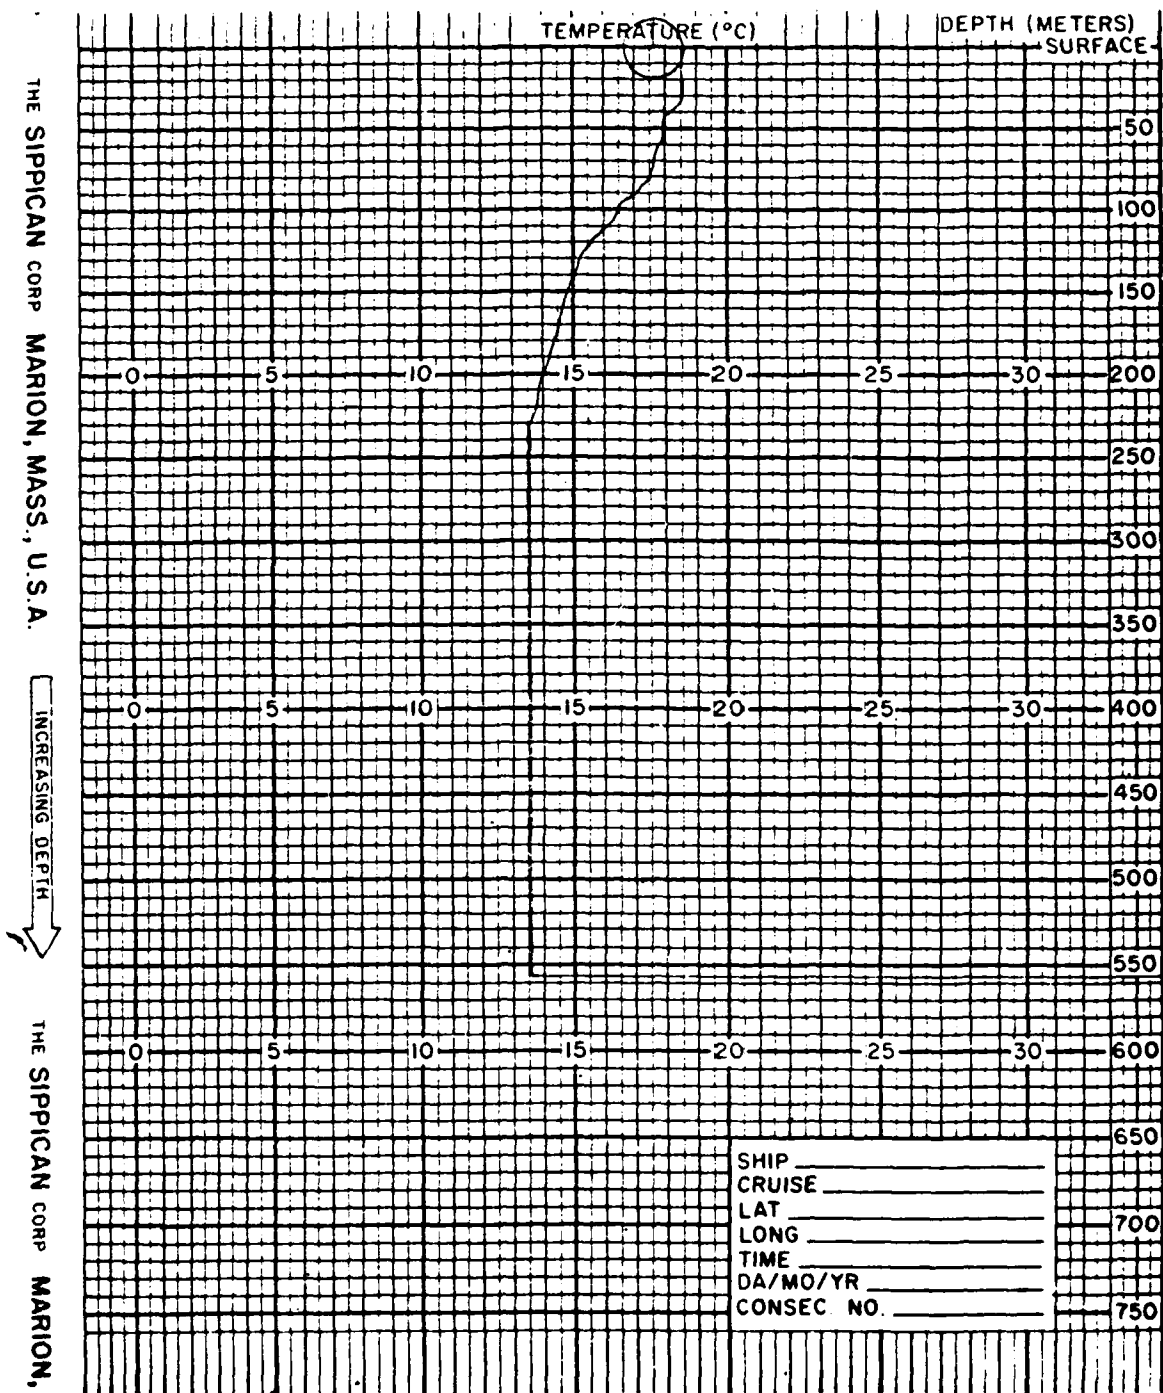
Figure 4 - Check mode calibration mark other than 16.7°C (appears at 17.7°C)

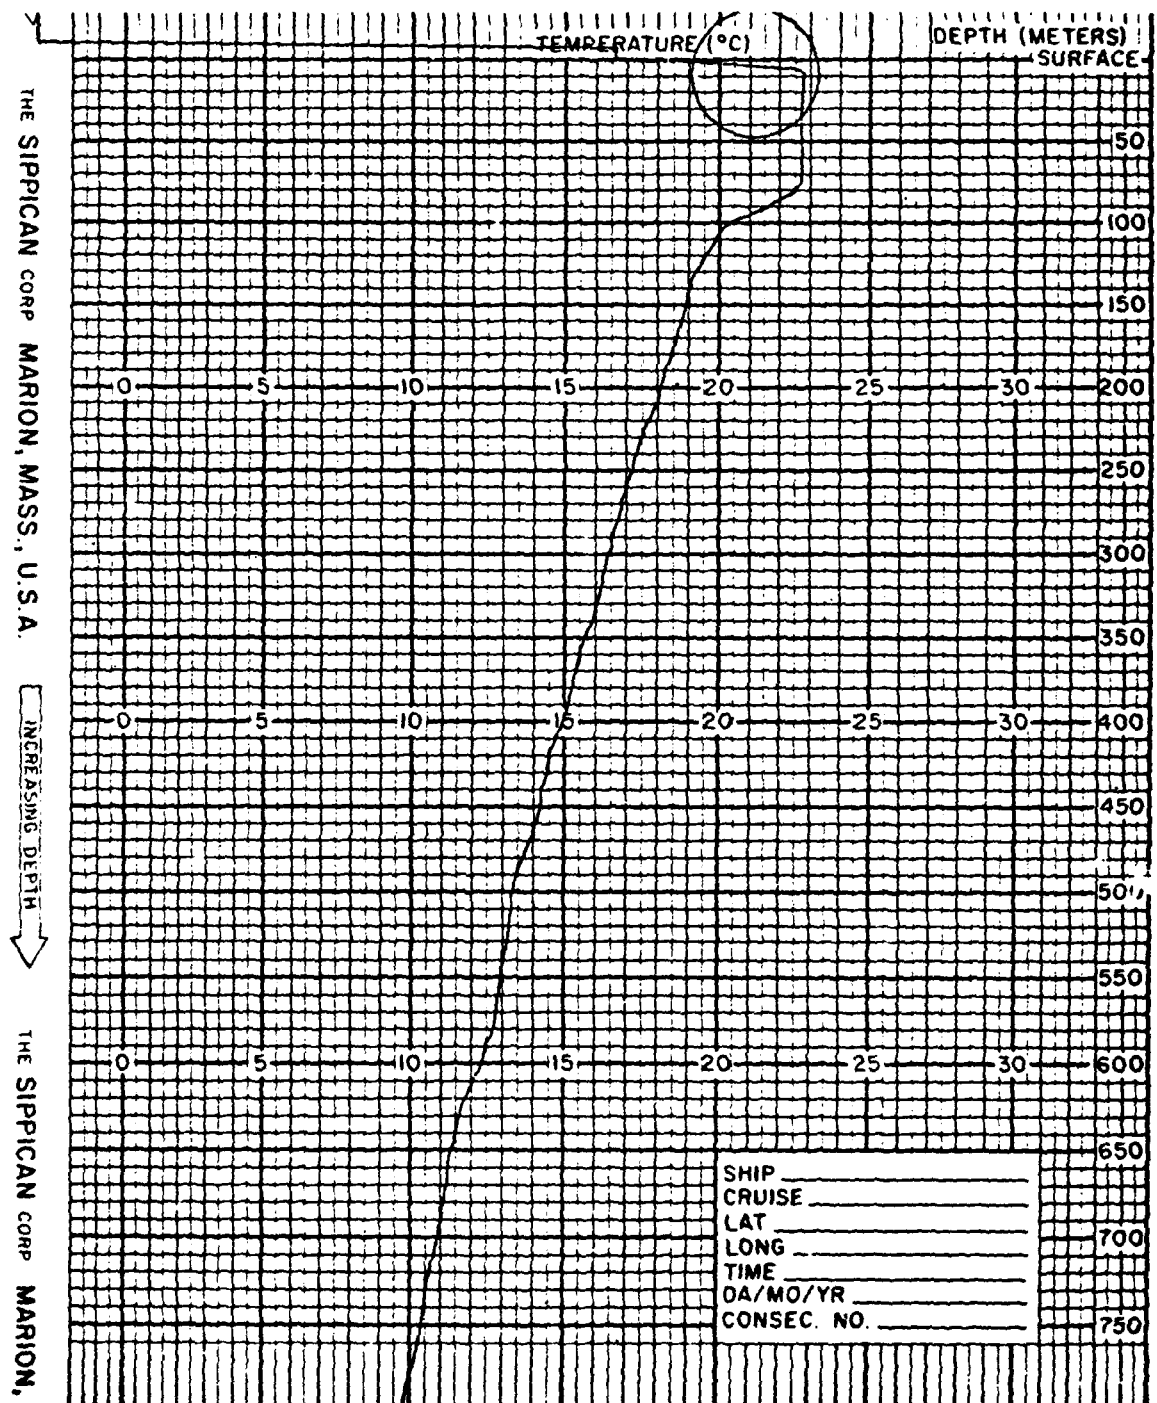
Category 2 - Recorder gain set incorrectly: Gain adjustment controls the stylus slew rate (stylus travel time across the chart) and the amount of stylus overshoot. With low gain setting, stylus response is slow and the trace exhibits a temperature lag most noticeable at the surface (figure 5). The trace is erroneous and should not be encoded. Recorder response to temperature change is slow for the entire trace, and temperature structure cannot be determined accurately. When gain is set too high, the stylus vibrates in the Check/Run Mode and overshoot exceeds the maximum allowable value of 0.5°C (1.0°F) (figure 6). Note: A 5 m negative depth correction must be applied to this trace because of depth offset at the surface.

Figure 5 - Recorder gain set too low (stylus slew response slow)

Gain and overshoot adjustment procedures are outlined in appendix B. If a gain check indicates that no adjustments are necessary, the probable cause of temperature lag is a faulty electrical connection in either the launcher cable or canister head contacts.

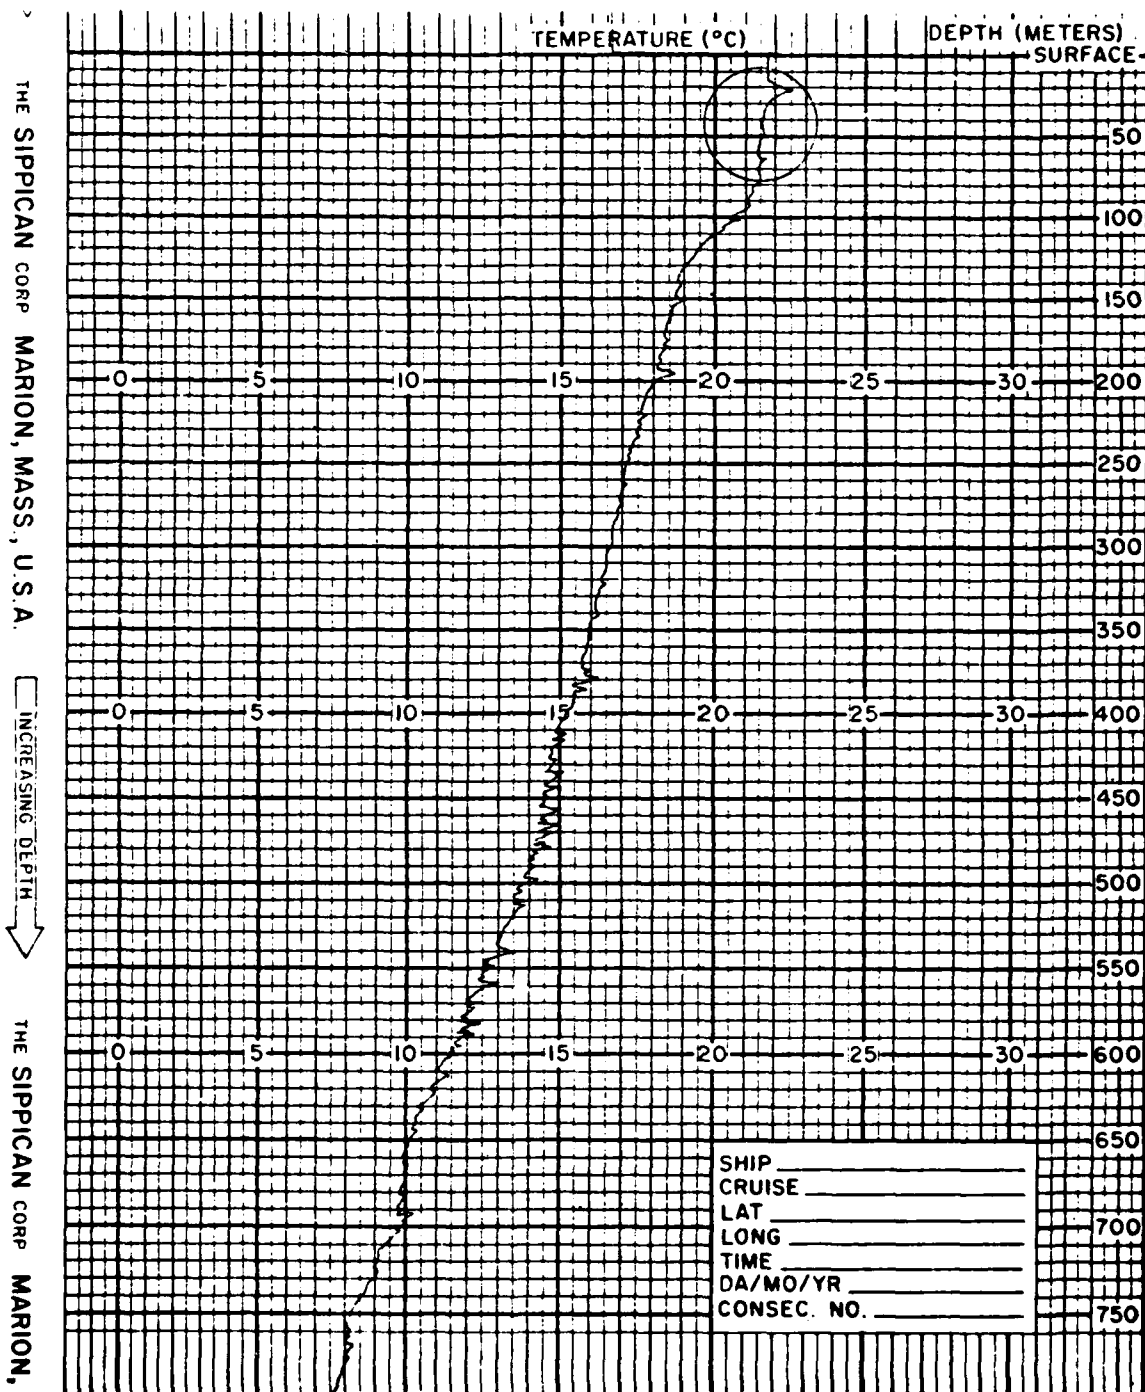
Category 3 - Noise > 0.2°C (0.4°F): Mechanical and electrical interference can influence recorder output. Mechanical noise (e.g., resonant vibration) produces open spiking (figure 7). When spiking is greater than 0.2°C (0.4°F), interference is greater than the accuracy of the system. The trace is therefore erroneous and should not be encoded. Additional probes should be launched until the problem disappears, because mechanical noise is usually intermittent. When encoding a trace with interference less than 0.2°C (0.4°F), the noise must be smoothed.

Figure 7 - Noise greater than  $0.2^{\circ}\text{C}$  (external mechanical interference)

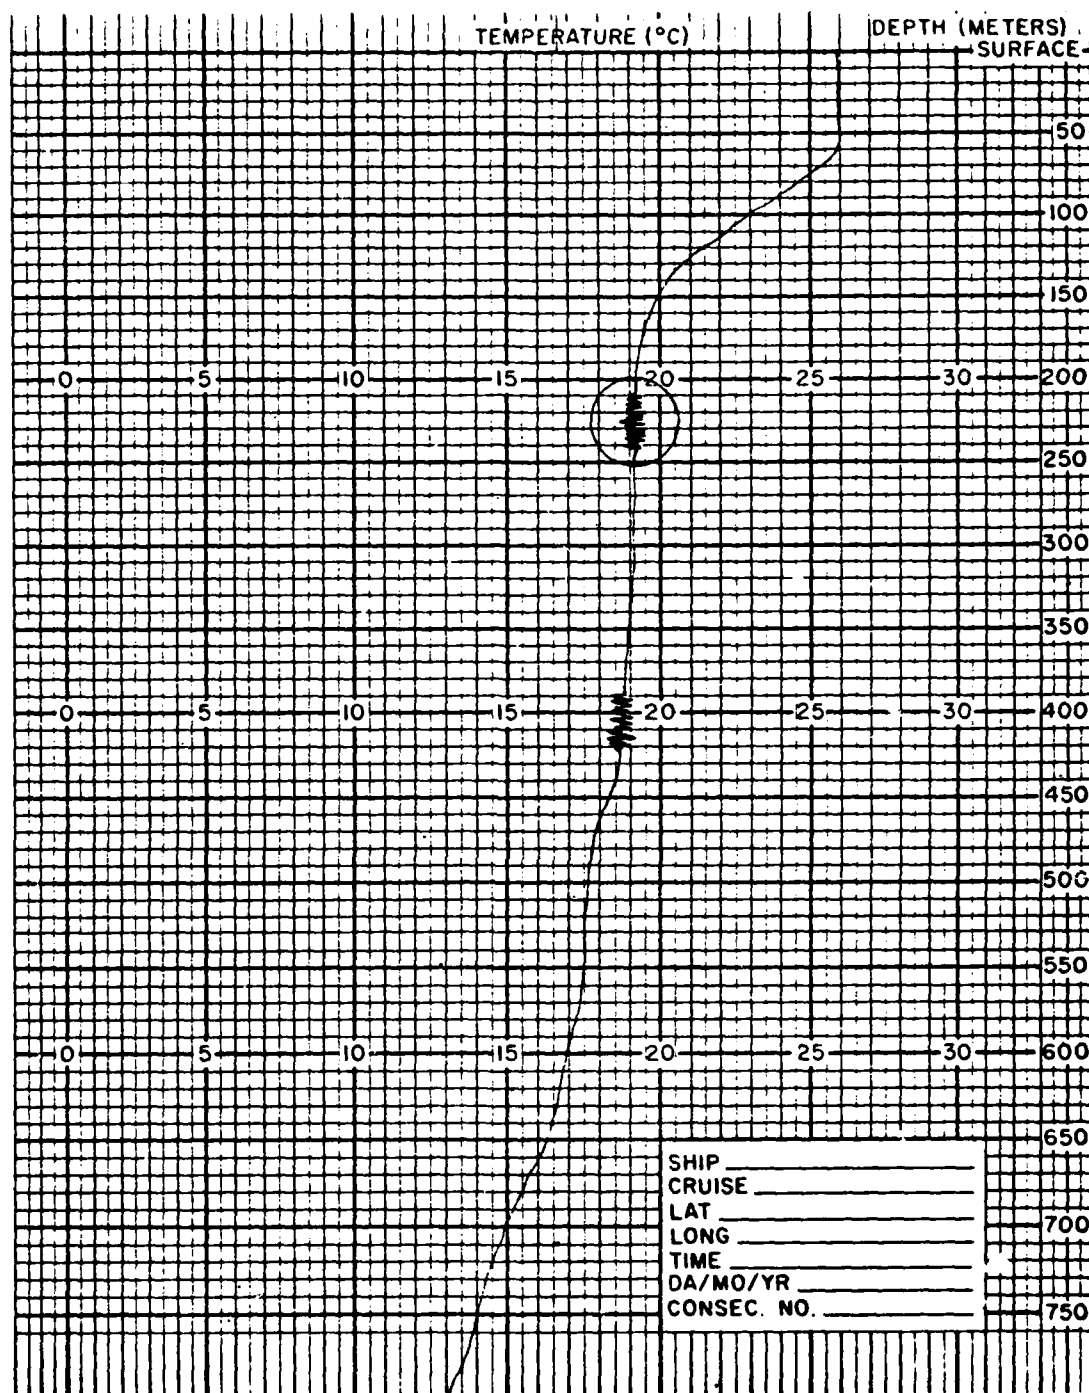
Electrical noise (e.g., interference from the ship's radio) causes symmetrical stylus deflections (figure 8). Since the noise is symmetrical, the trace can be smoothed through the center of the deflections.

Figure 8 - Electrical noise

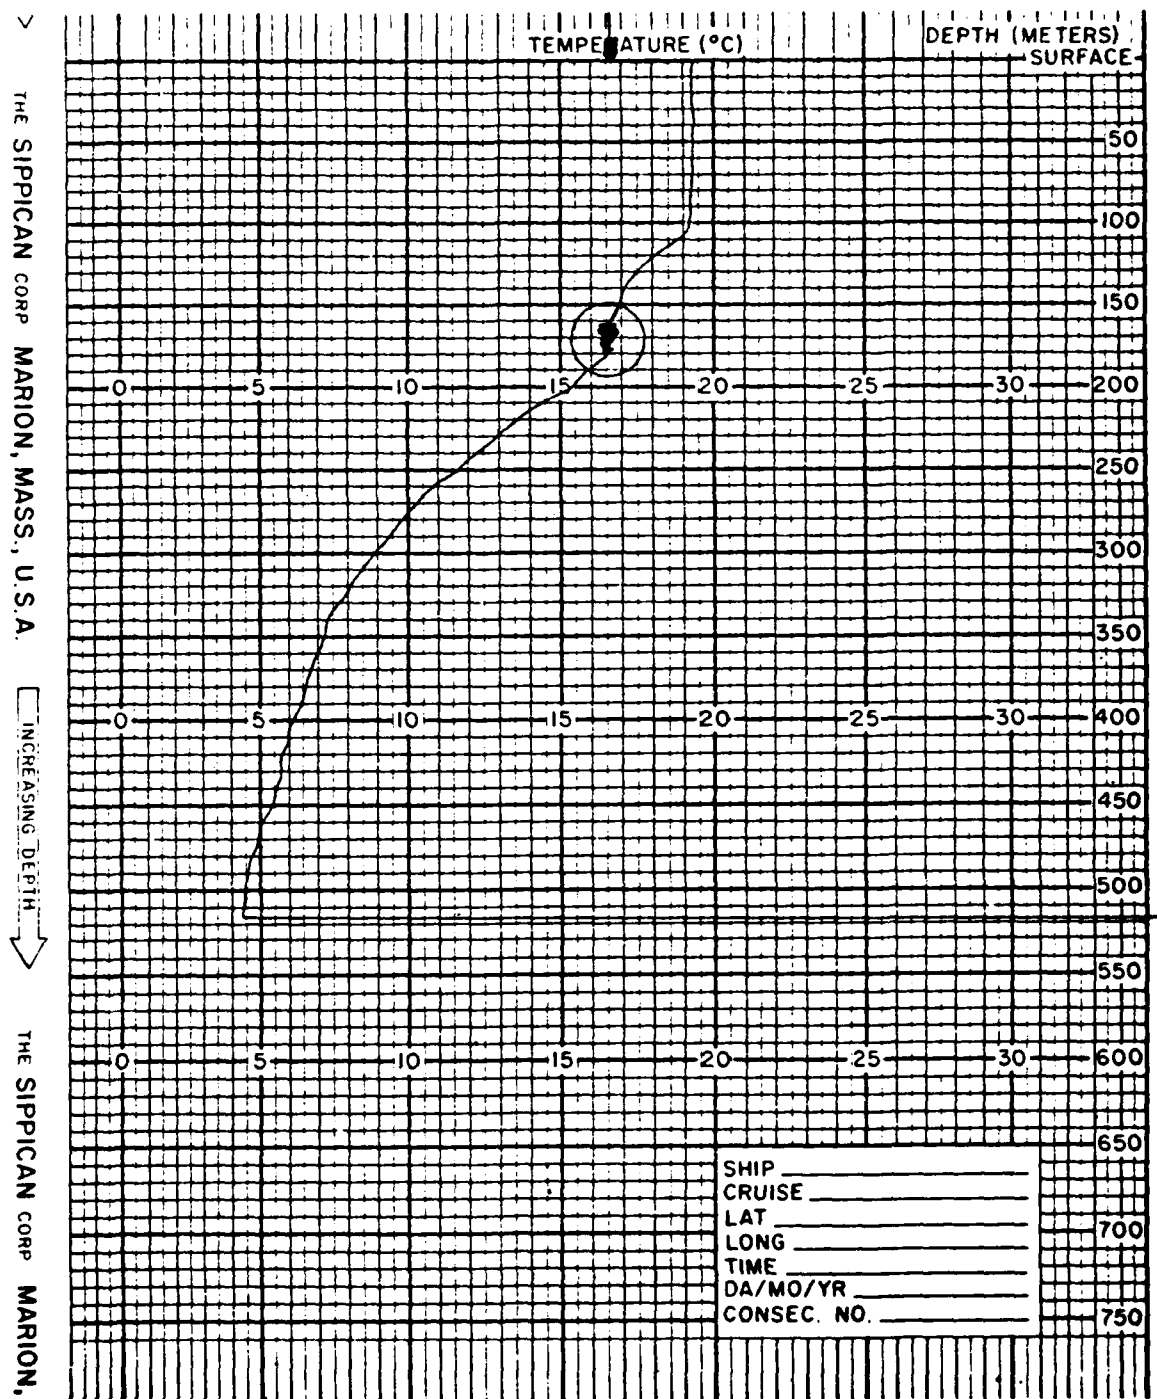
Sometimes a "flat" spot occurs in the potentiometer of the recorder. This will cause a vibration at 16.7°C (62°F) on the trace (figure 9) during both the Check/Run and Measure Modes. As with electrical interference, the trace can be smoothed through the vibration.

Figure 9 - Servo potentiometer "flat" spot at 16.7°C

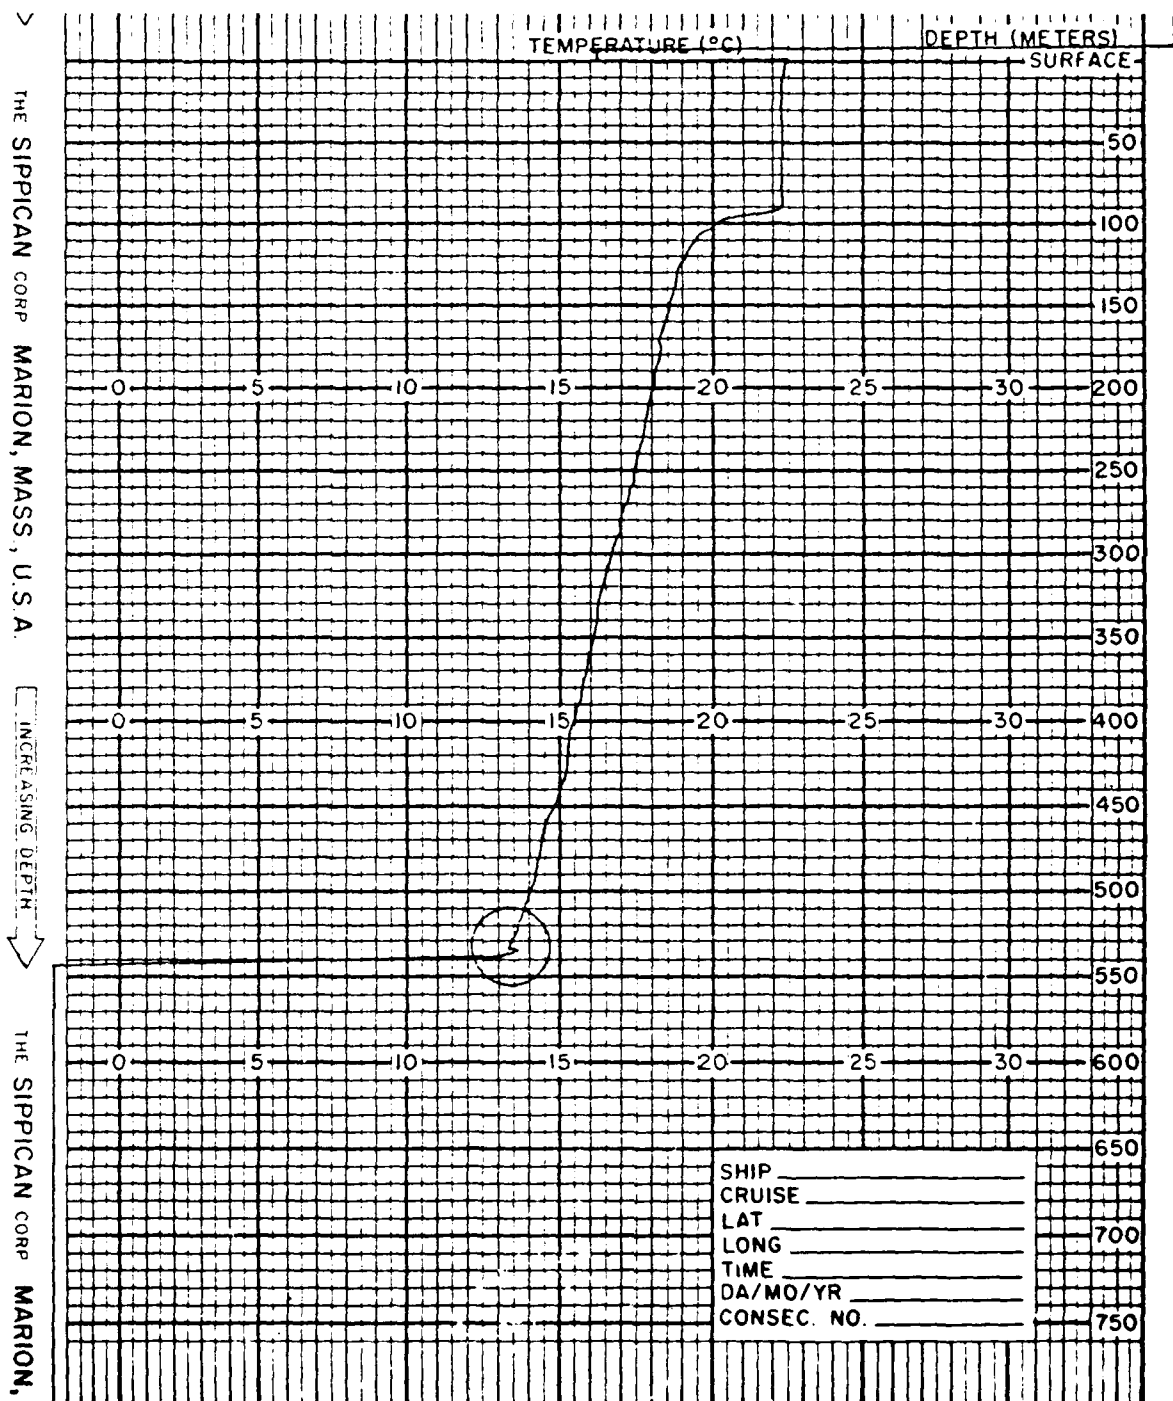
Category 4 - Wire break: Figure 10 shows an obvious failure at 535 m. The cause appears to be due to initial wire fouling on the ship (spike to high-temperature side) followed by wire break. This trace is usable to 535 m. In this case, the wire broke from the spool in the launcher and the open circuit caused the stylus to travel off-scale at the low-temperature end. When the wire breaks from the descending probe's spool, the short circuit drives the stylus to the high-temperature end of the scale (figure 11).

Figure 10 - Fouling followed by wire break at launcher

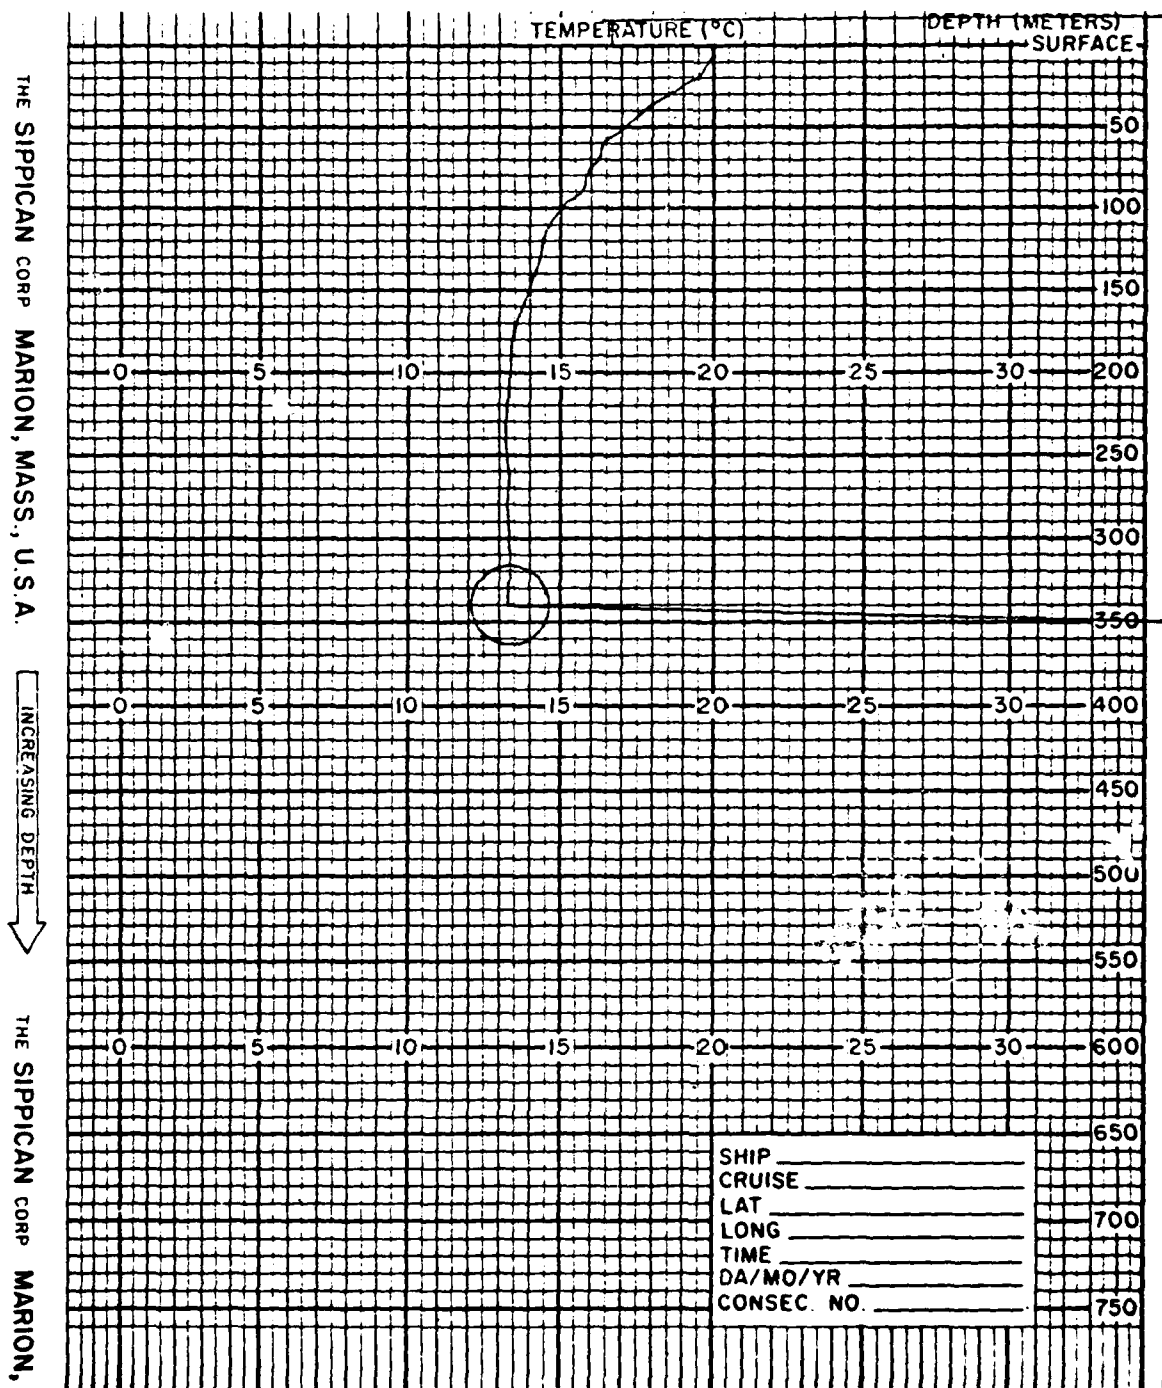
Figure 11 - Wire break from probe spool

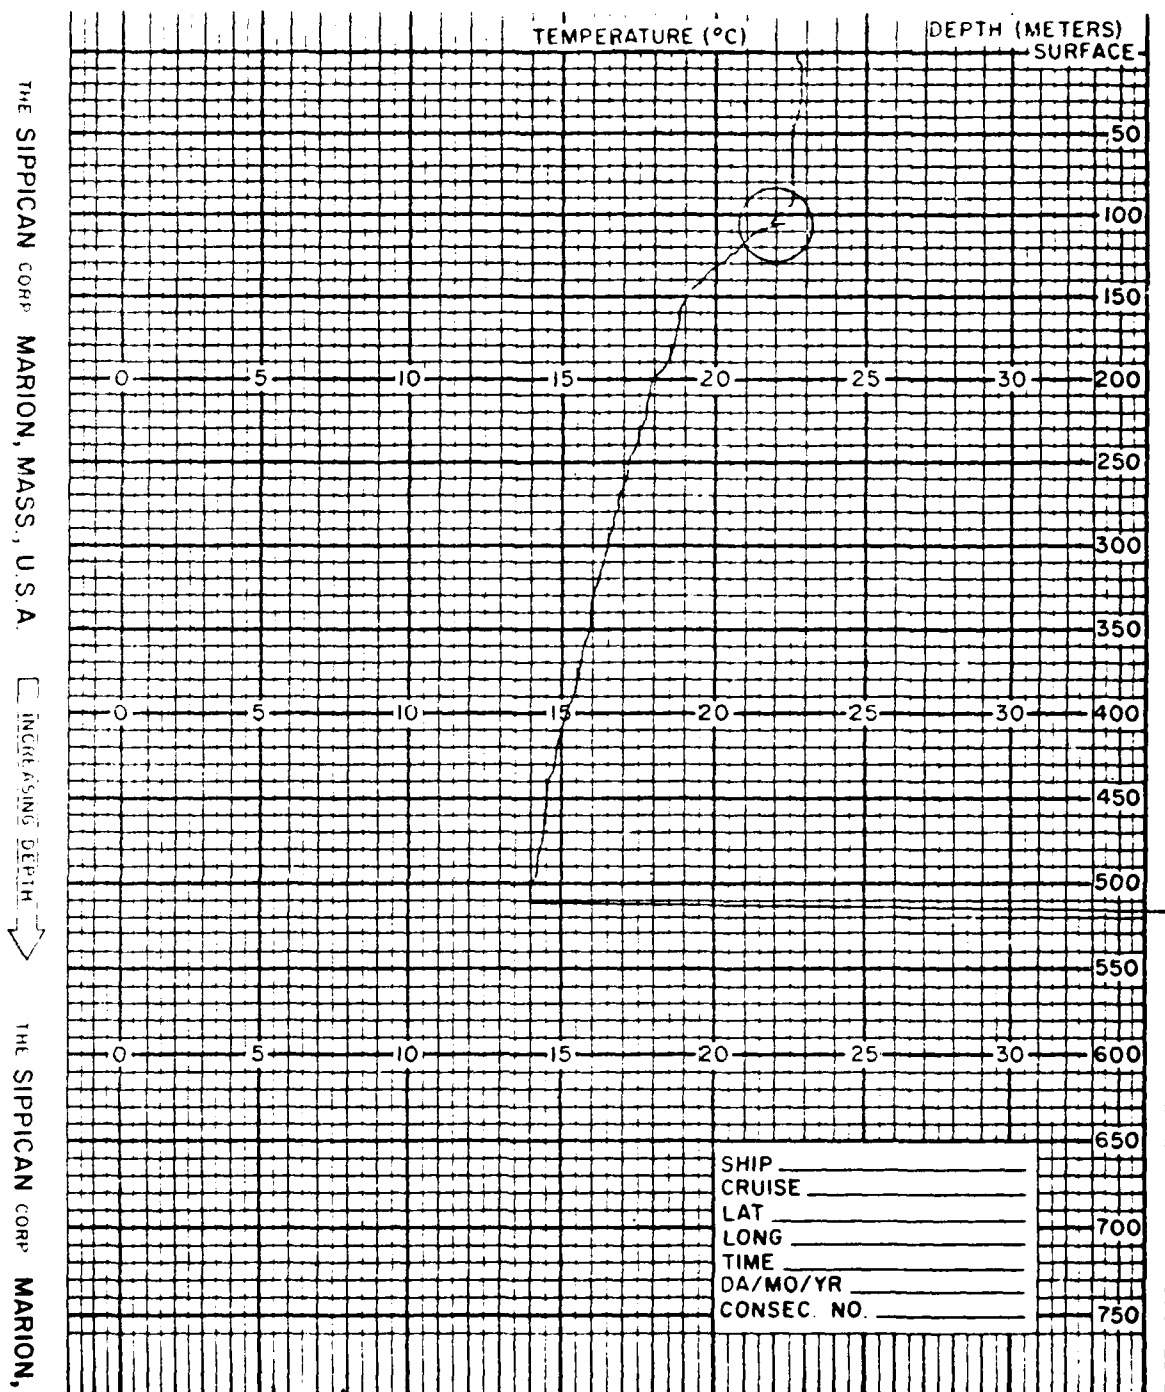
Category 5 - Insulation penetration: Several possible causes can lead to wire insulation damage followed by leakage, represented on a trace by a sharp spike toward the high-temperature end of the scale (figures 12 and 13). Two of the most common causes of damage include wire contact with the ship's hull or wire hangup on a metal burr at the open end of the launcher tube. Data recorded below the initial insulation penetration are erroneous even though the insulation damage tends to heal itself through interaction between wire and seawater. However, recovery from the damage is never complete.

Figure 12 - Wire insulation penetration (at 105 m) with attempt at recovery

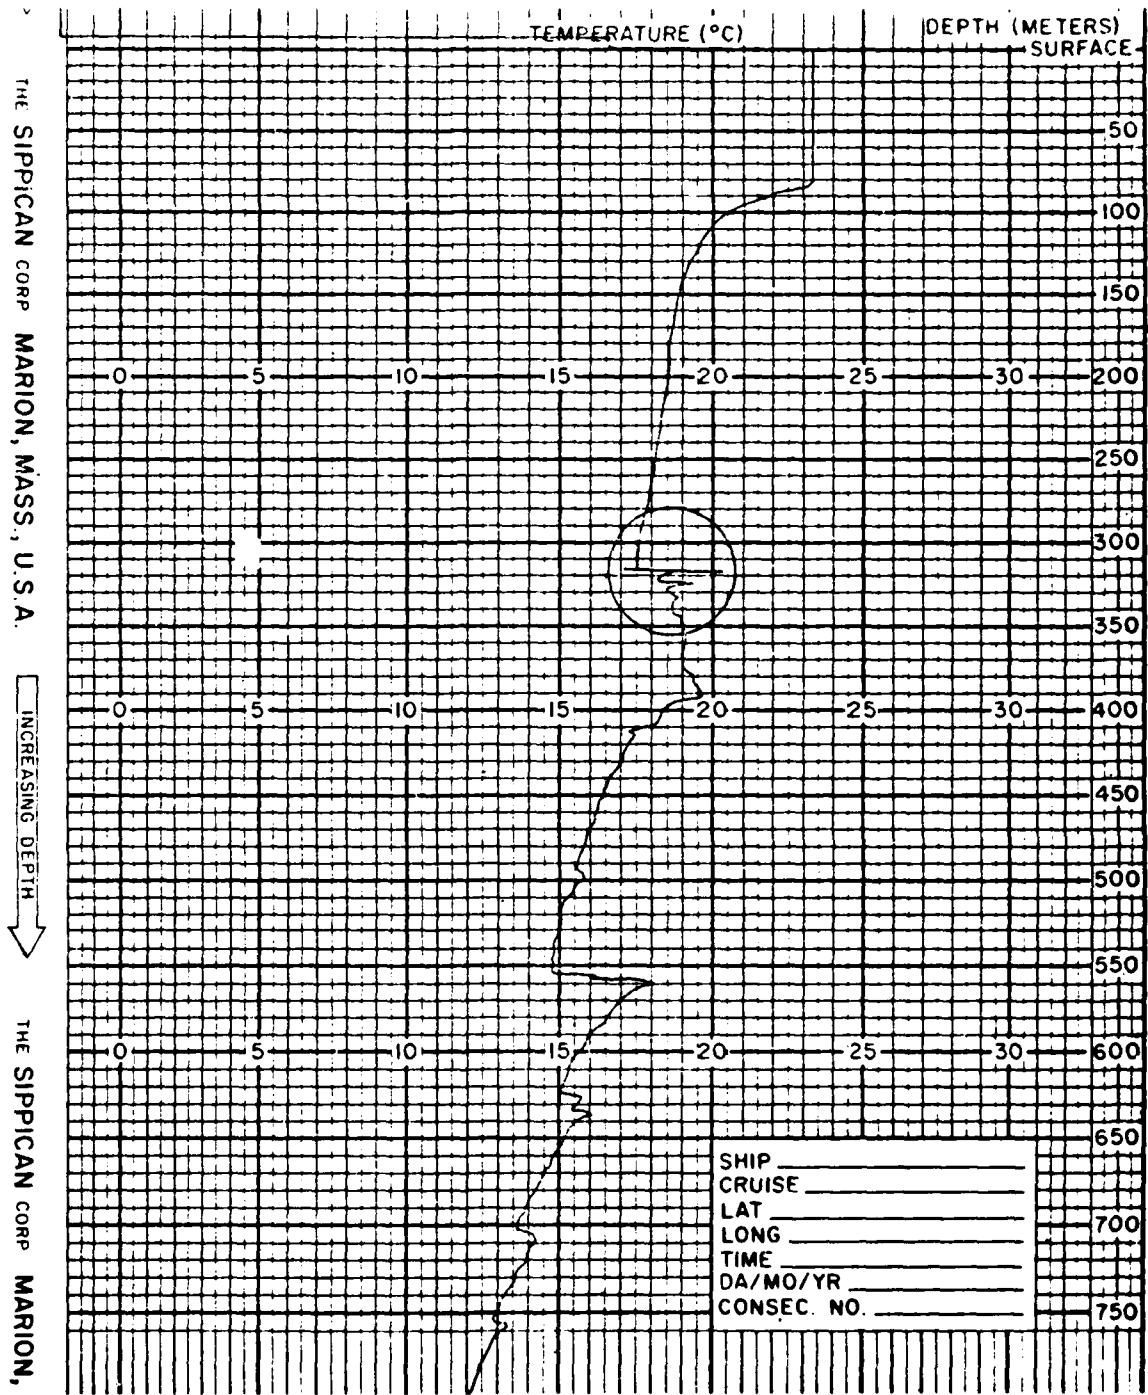
Figure 13 - Wire insulation penetration (at 318 m) followed by continuous leakage

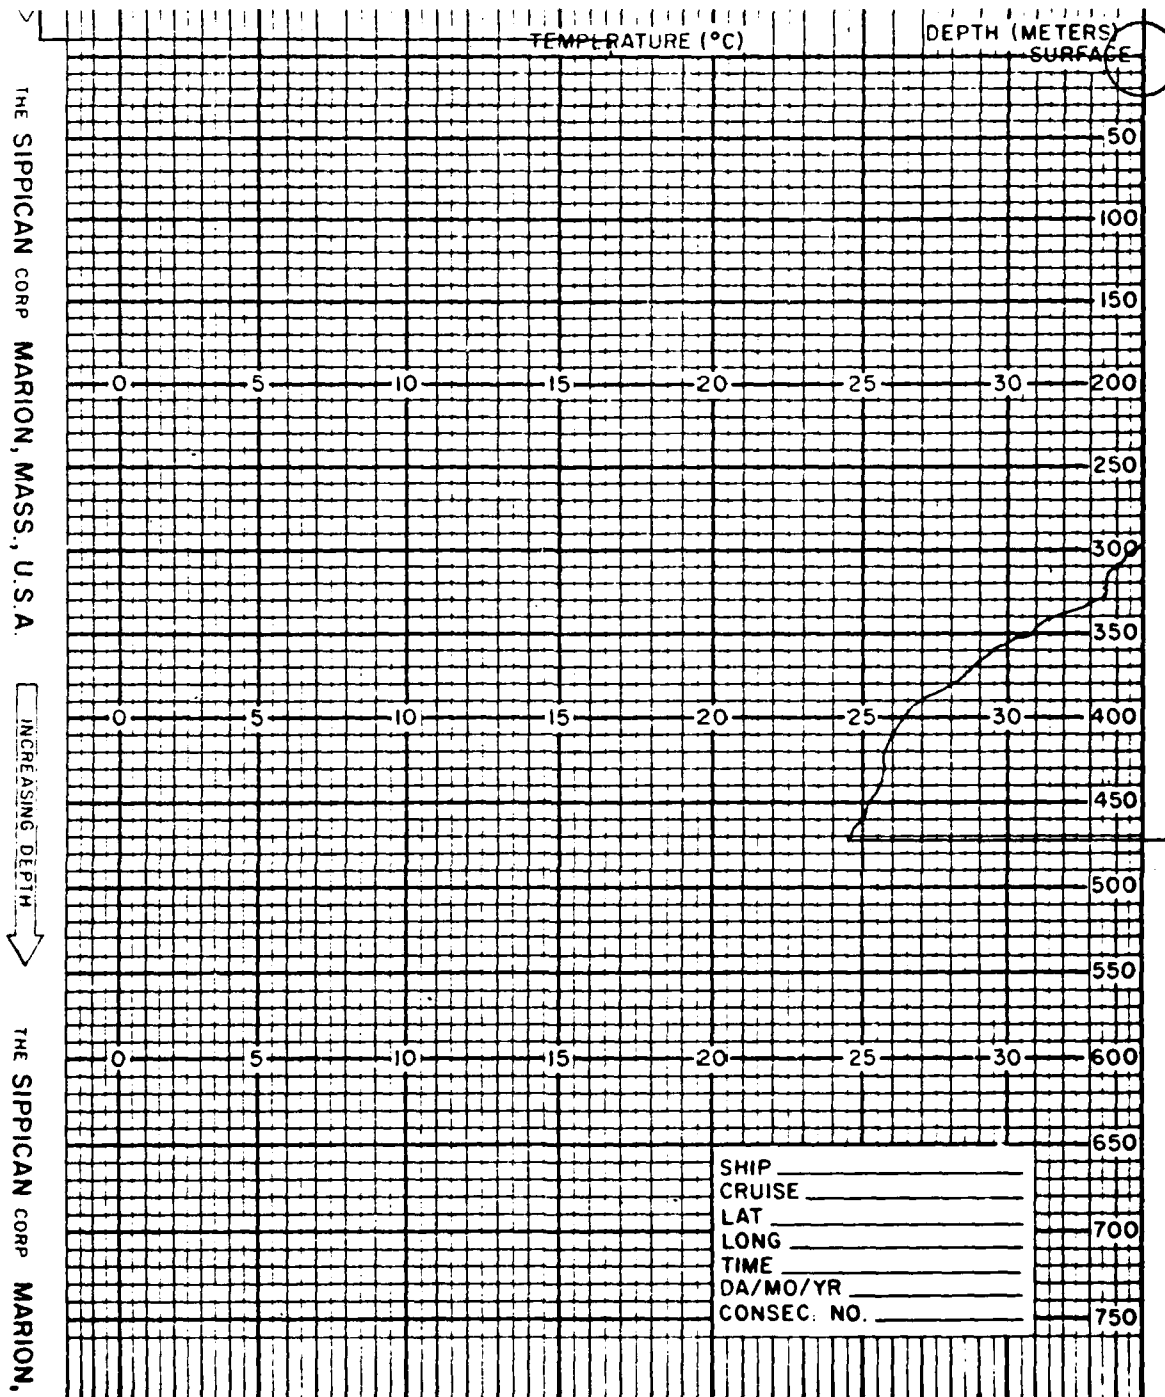
Figure 14 displays leakage in one of a probe's pair of wires. This leakage causes a trace to show excessive temperature at depth. Another probe should be launched in such cases.

Figure 14 - Wire leakage

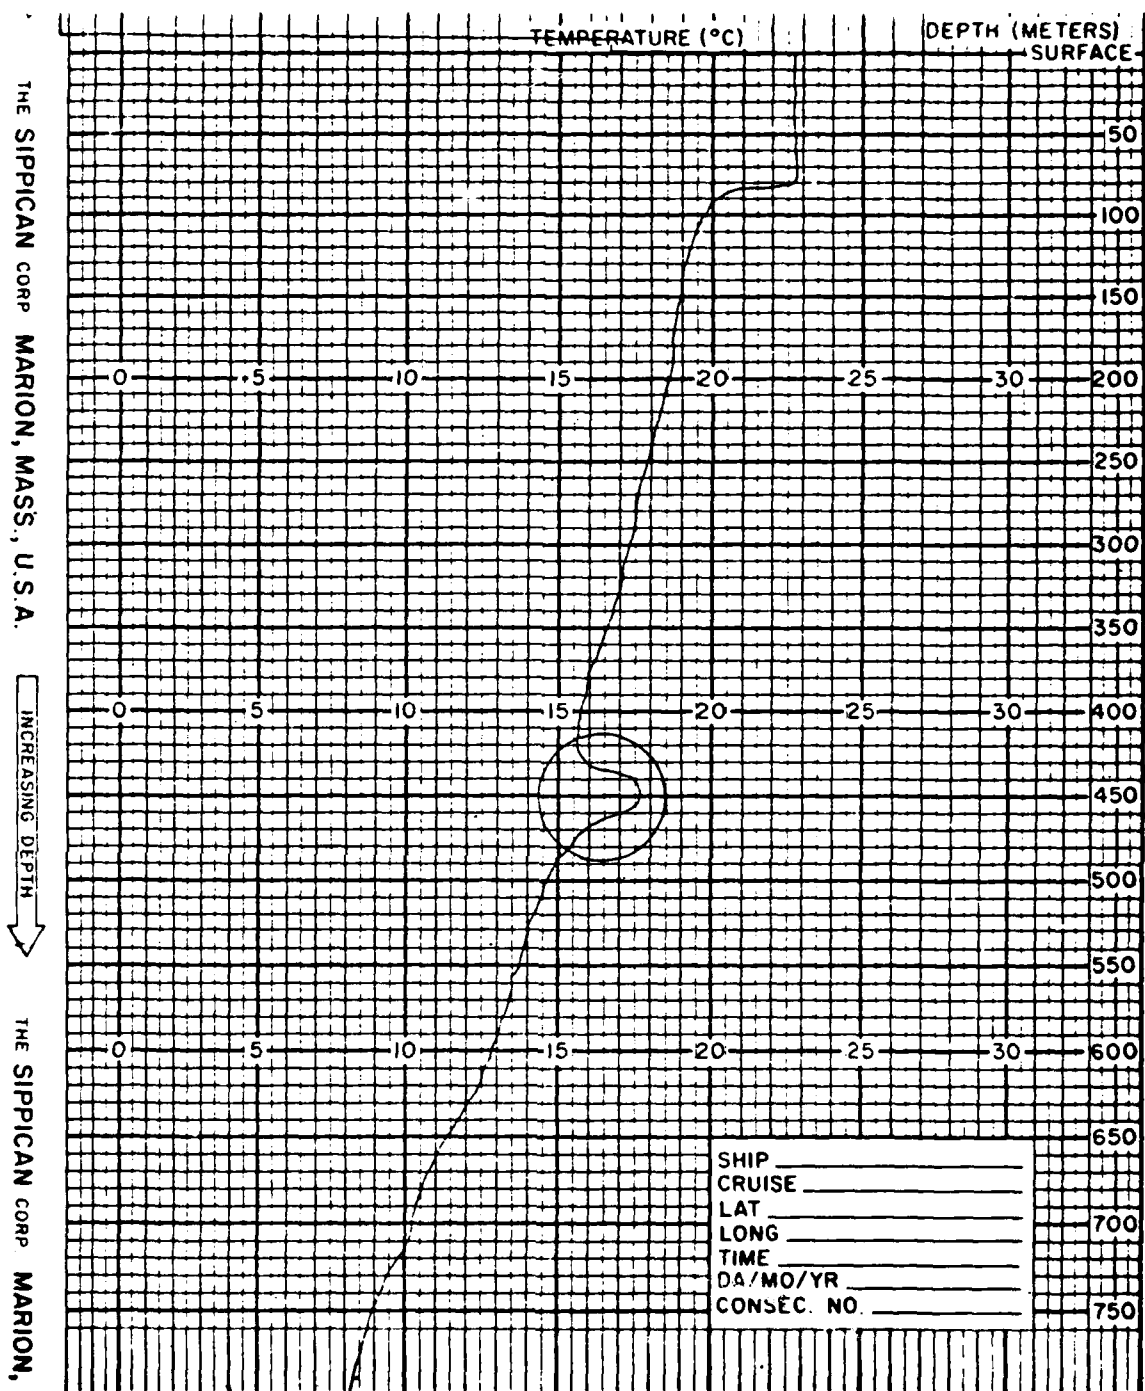
Category 6 - Wire stretch: Increased tension due to poor wire unreeling leads to wire stretch. This results in a characteristic bulge to the high-temperature side that can occur at any point in the trace (figures 15, 16, and 17). Data recorded beyond the stretch point are erroneous because of a permanent change in the conductive characteristics of the wire.

Figure 15 - Wire stretch (good to 405 m)

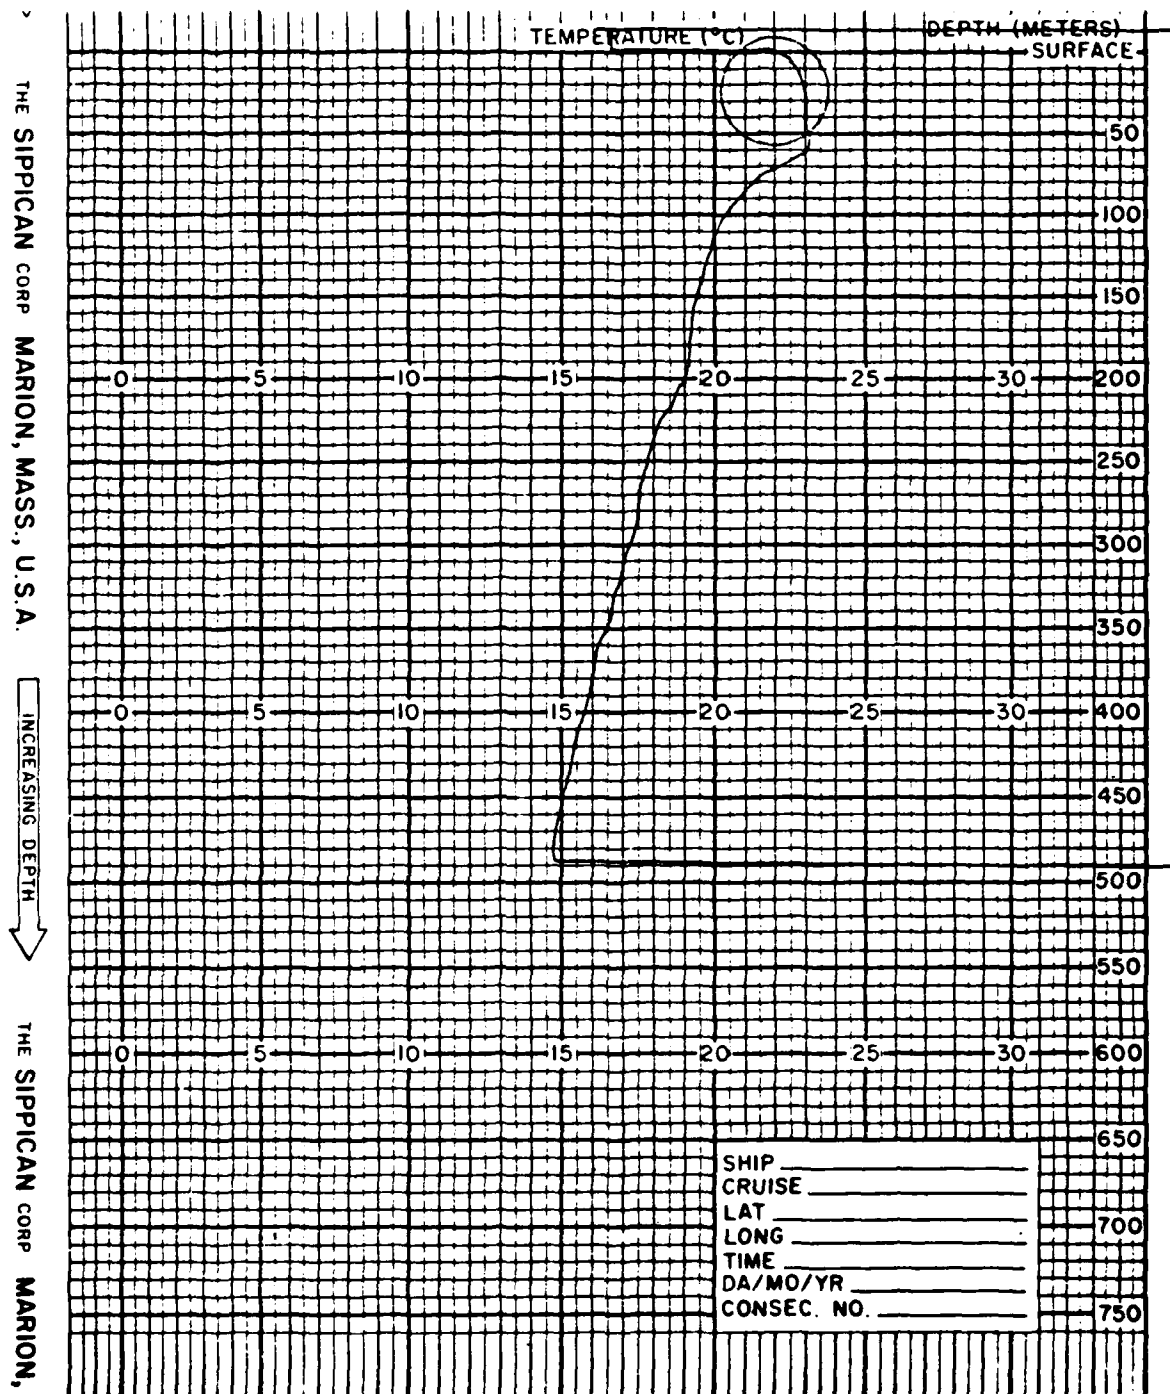
Subtle wire stretch within the mixed layer (figure 16) has recently been documented during several oceanographic experiments (Dugan and Schuetz, 1977). These features appear on traces using stock Navy T-4 probes (460 m/1500 ft). This malfunction seriously degrades data quality by affecting the temperature gradient and thickness of the mixed layer. Failure rate in excess of 70 percent has been noted for T-4 probes more than 4 years old.

Figure 16 - Wire stretch in mixed layer (trace is no good)
